**Grant Alternative School**

**Building Analysis and Review of the Visual (Cost & Picture) Report**

**We Have taken this opportunity to complete our report in reply to the Visual (Cost & Picture) Report completed for Grant Alternative School dated August 16, 2000.**

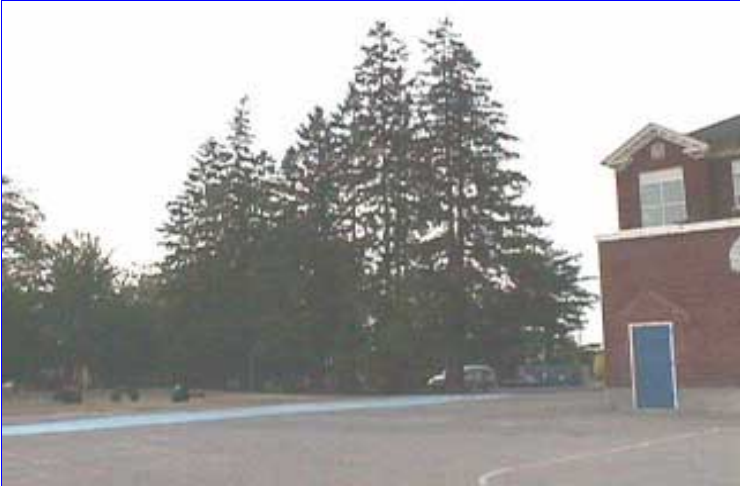
The next group of photos shows the condition of the Grant School paved areas. The majority of areas are in excellent condition and only minor repairs and crack sealing should be completed for the foreseeable future.

**There is only some minor cracking on all paved areas**

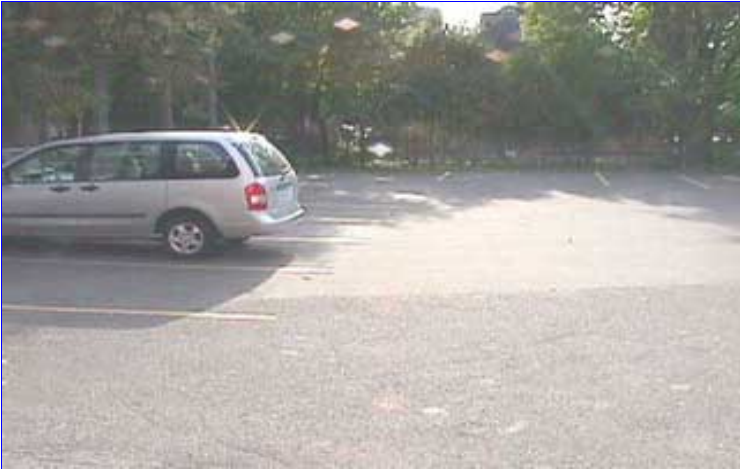
**The parking area was repaired last year**

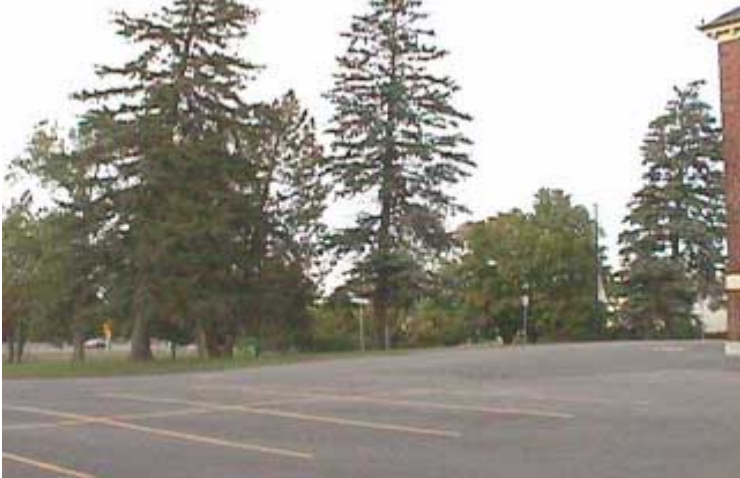
**The entrance drive was also repaired last year**

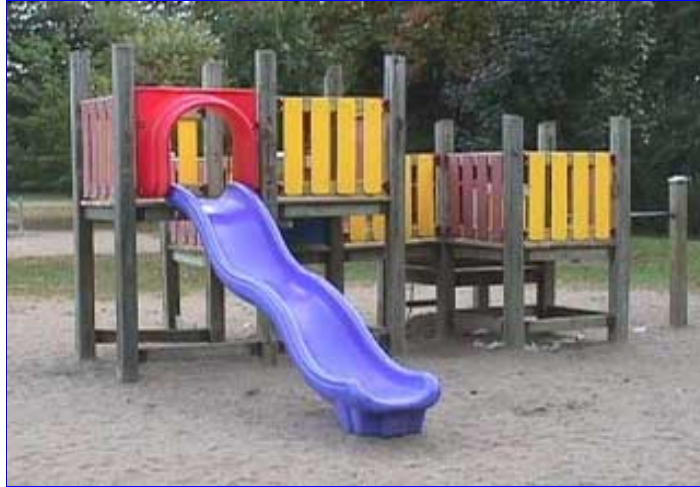
The play structures were recently upgraded to meet the Board's new safety standards

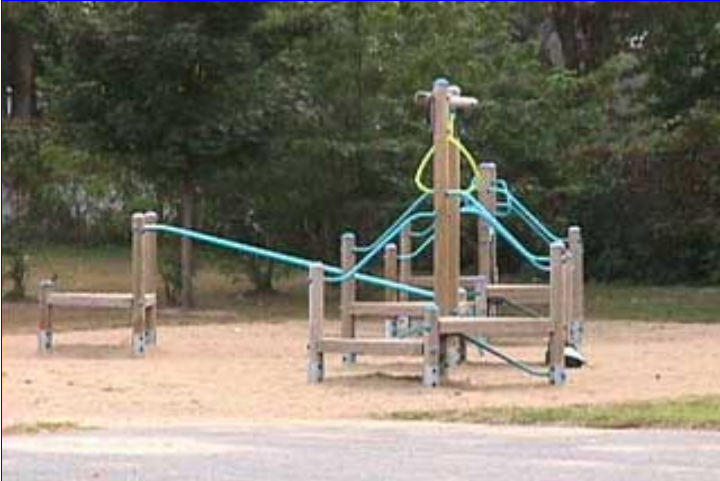
**This structure was newly installed 2 years ago**

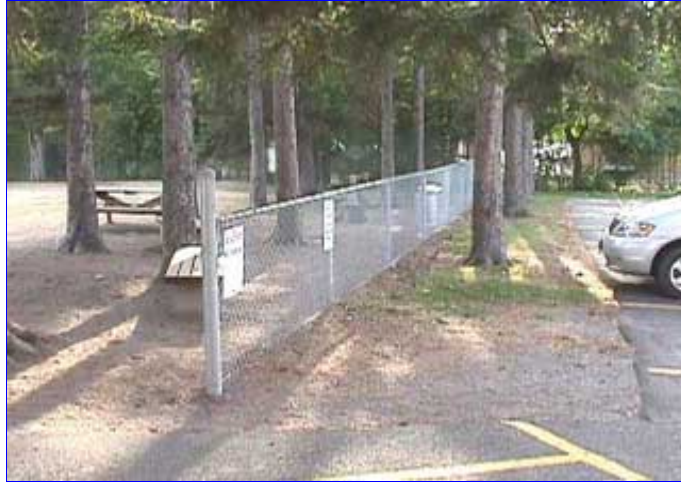
**This fence is in perfect condition**

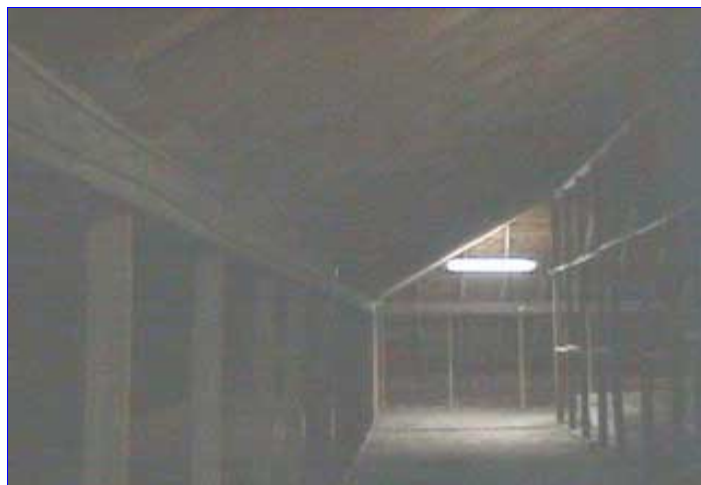
**The wood frame structure of the existing building roof which is in excellent condition**

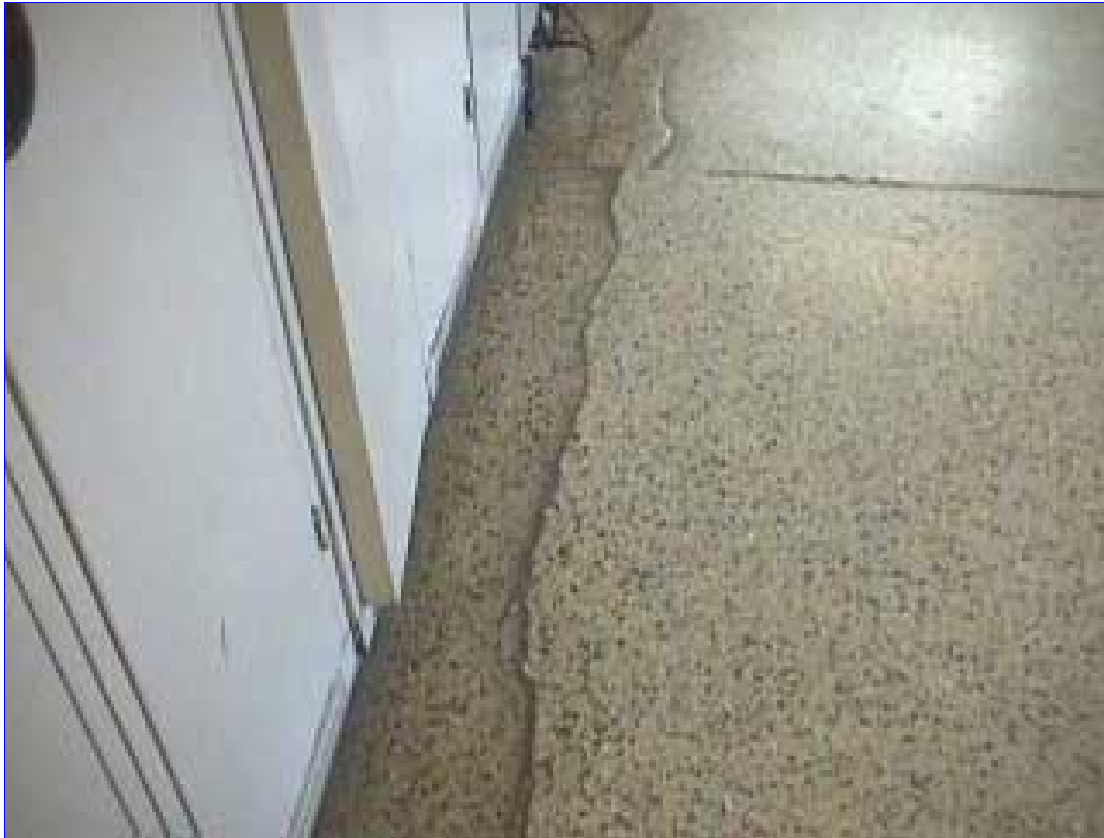
The settlement cracking in the terrazzo appears to have been caused by poor under slab compaction. The floor most likely cracked the first two years after construction. No cracking was observed on the walls, ceilings or exterior masonry. No structural concerns are evident.

**Settlement cracking in the terrazzo floor of the annex**

The repairs to the terrazzo can be completed as inexpensively as minor grinding and the use of leveling compound. The floor can be painted, as it is the majority of the main building. Terrazzo repairs would also be inexpensive; however, matching the terrazzo chips may prove to be difficult.

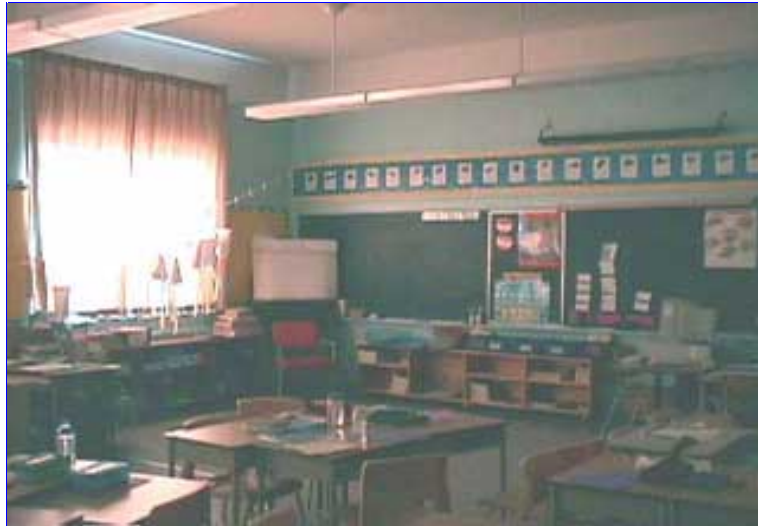
**The existing painted millwork is in great condition. If work is required, it most likely would include cabinet hardware adjustment or replacement, which could be completed at a fraction of the \$115,000.00, budgeted in the Board's report. The materials and workmanship used to construct the cabinetwork would be difficult to match at this time.**

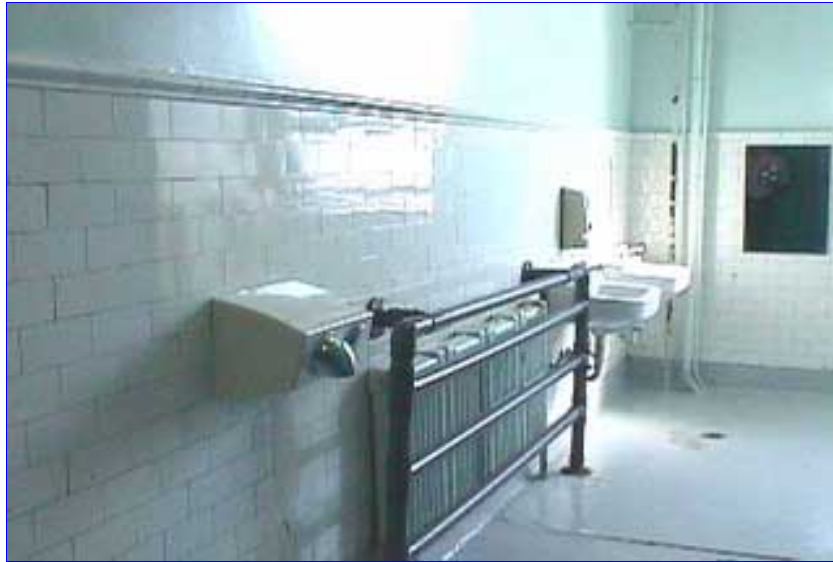
**The 80-year-old ceramic tile is still gleaming**

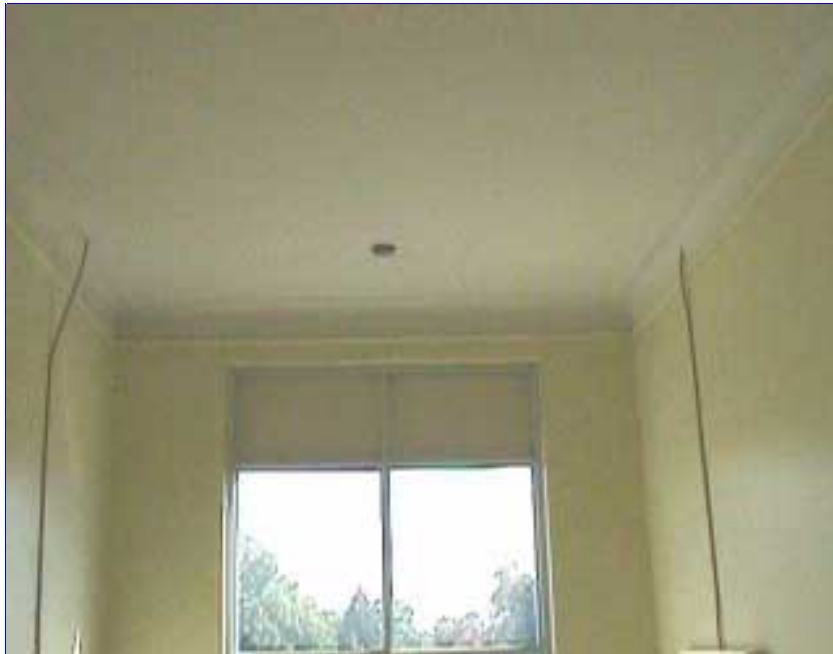
**The plaster walls and ceilings are in remarkable condition**

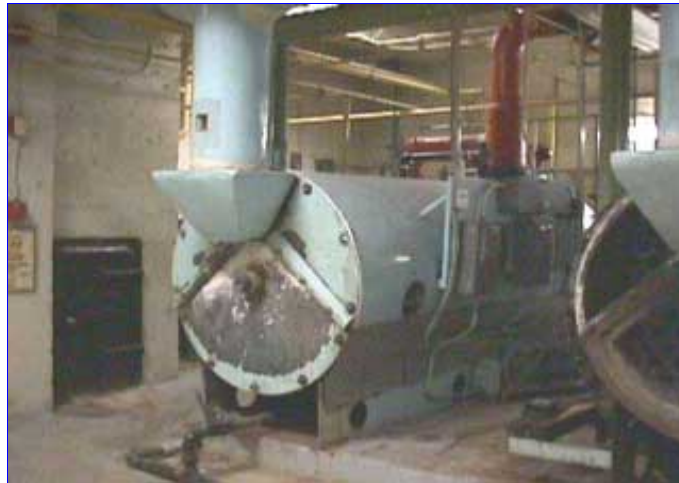
The boilers have been re-cored this summer and appear to be in fine condition. The steam and hot water radiation system should last for many years if the water is conditioned properly. All piping and radiators reviewed appear in good condition.

**The existing boilers have just been re-cored**

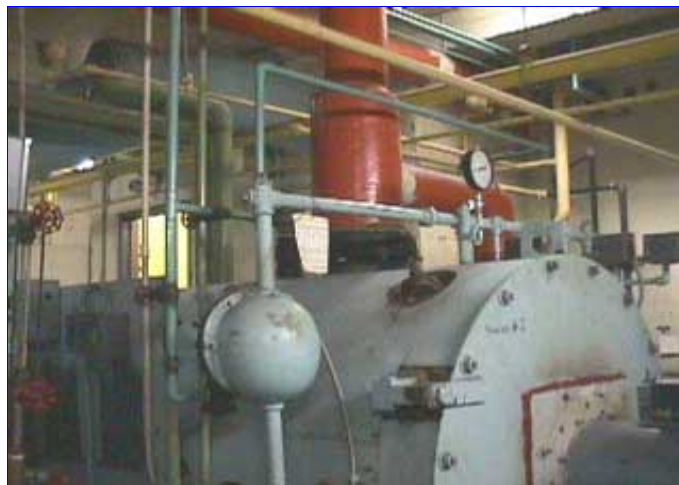
**The piping and pipe insulation is in good condition**

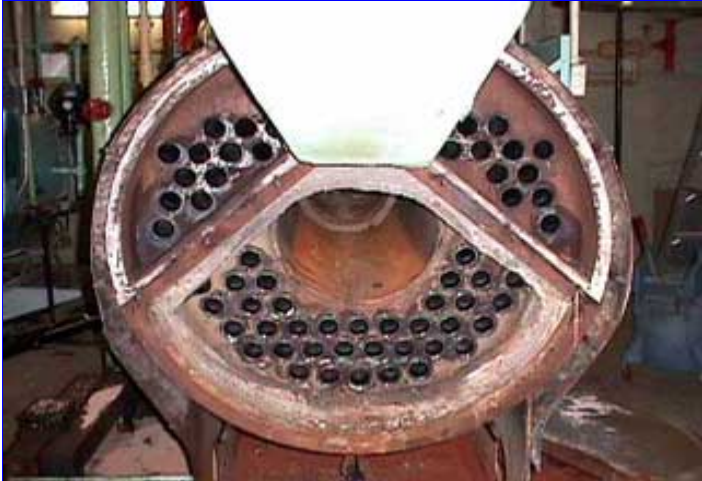
Photos of the re-corded boilers

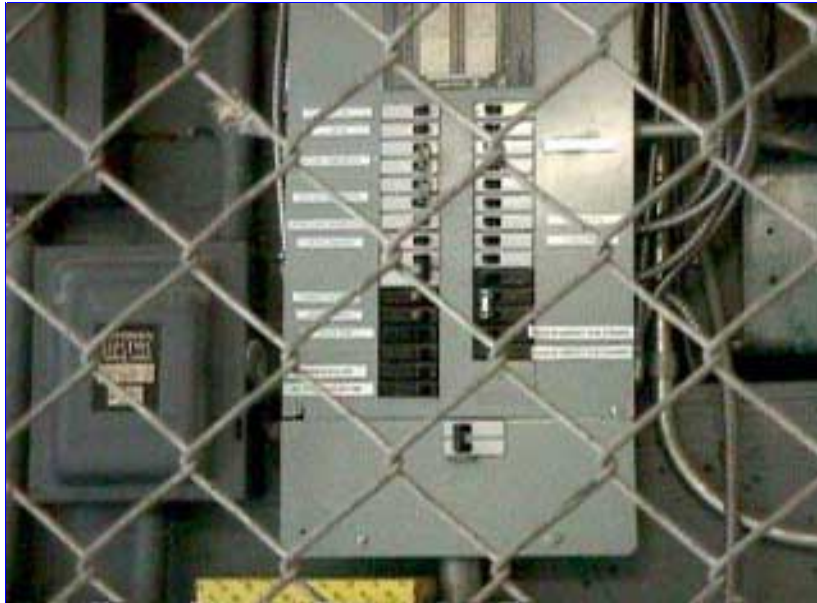
The majority of breakers and fuses have recently been replaced. The majority of distribution and switchgear equipment appears to be well maintained and in good condition.

**The panels and boxes have new breakers and fuses**

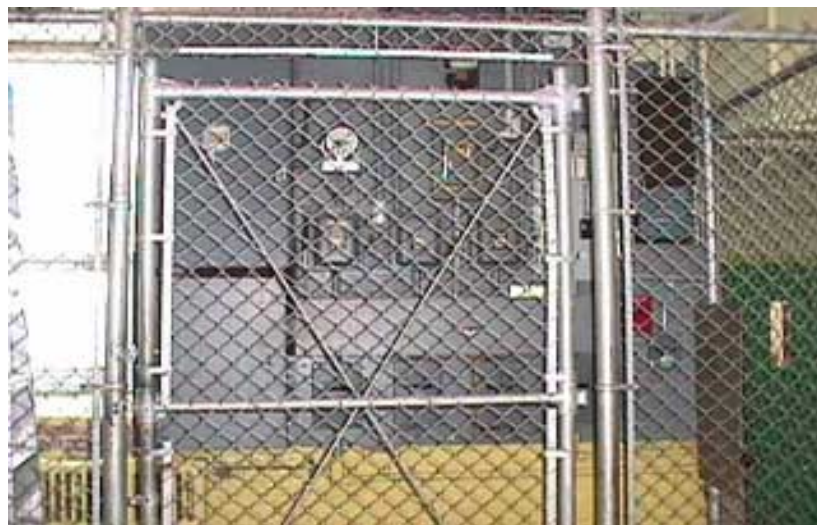
**The wiring is clean and well maintained – much of which is new armoured cable**

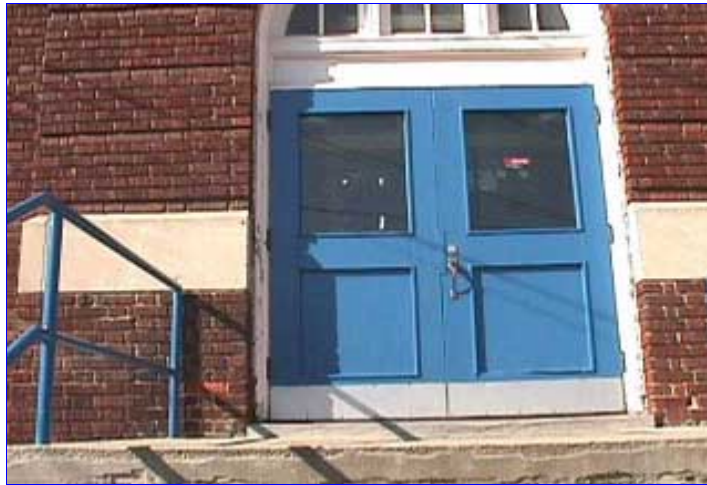
- No monies outlined for asbestos abatement.
- No note for any exterior painting.
- The rainwater gutters and downspouts require review and repair.
- The rear eastern stair of the main building is badly spalled and poses a safety hazard.
- Some of the face brick on the main building have spalled and should be re-pointed as soon as possible to prevent further damage to the exterior skin.

**Concrete repairs required for the southeast stair**

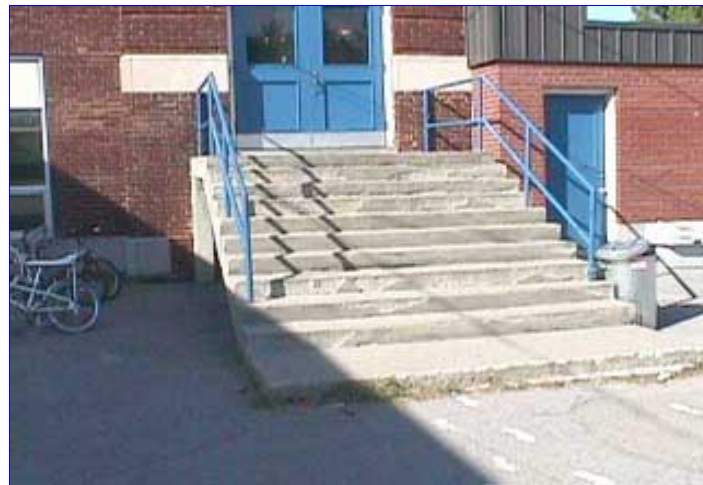
**The spalled concrete is a safety hazard**

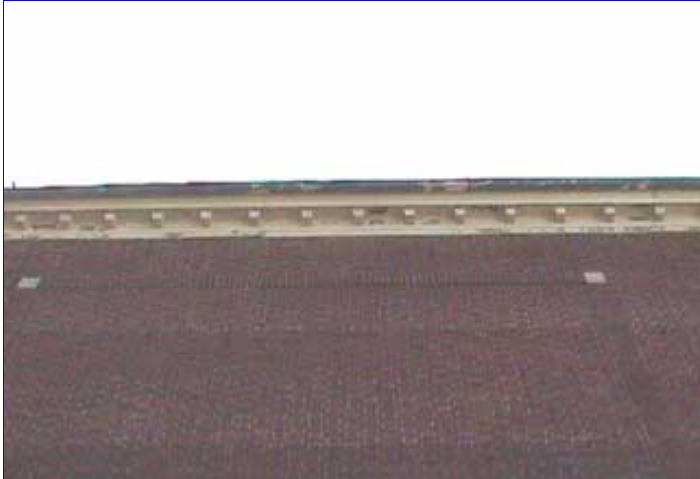
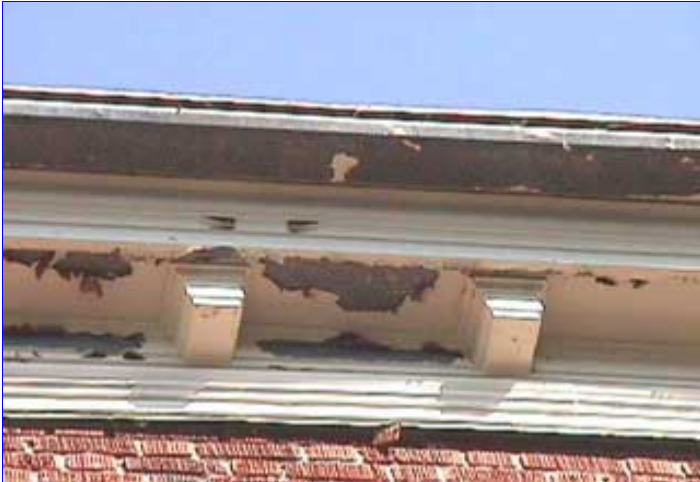
**The main building gutters require repairs and new down spouts**

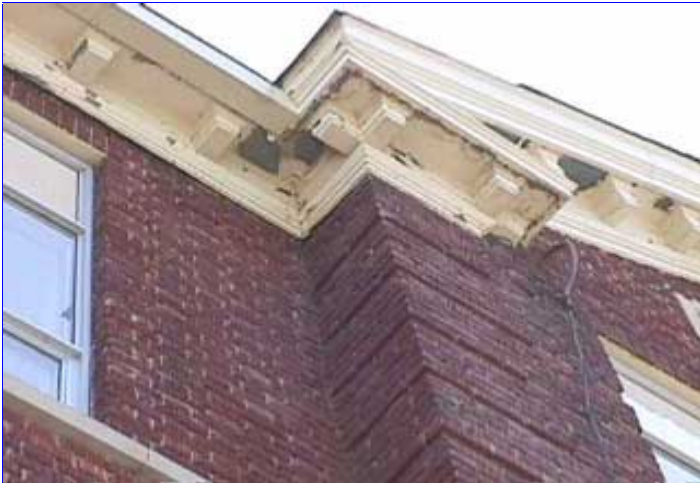
**The painting of the main building soffit and fascia is in poor condition**

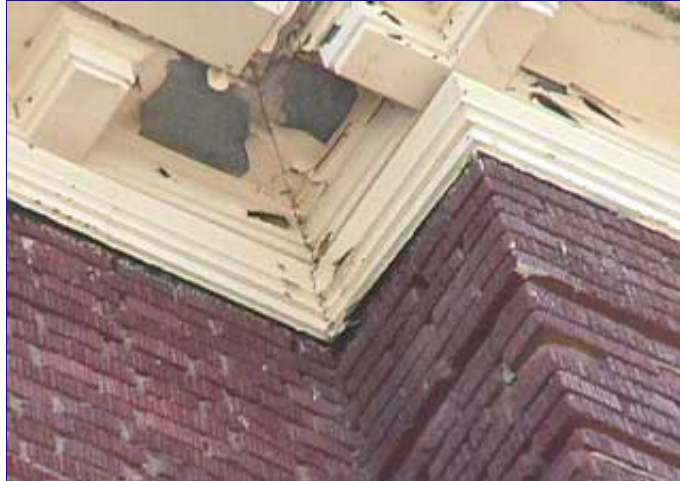
The exterior is in need of painting
