**Grant Alternative School**

**Building Analysis and Review of the Visual (Cost & Picture) Report**

**We Have taken this opportunity to complete our report in reply to the Visual (Cost & Picture) Report completed for Grant Alternative School dated August 16, 2000.**

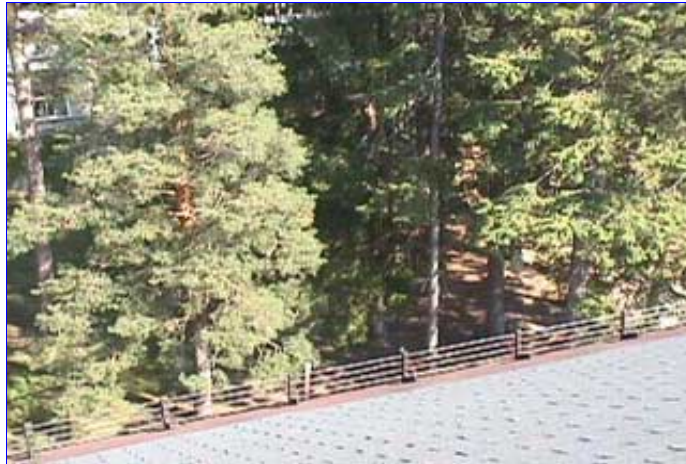
**Main building – shingled roof with ice fence around the perimeter**

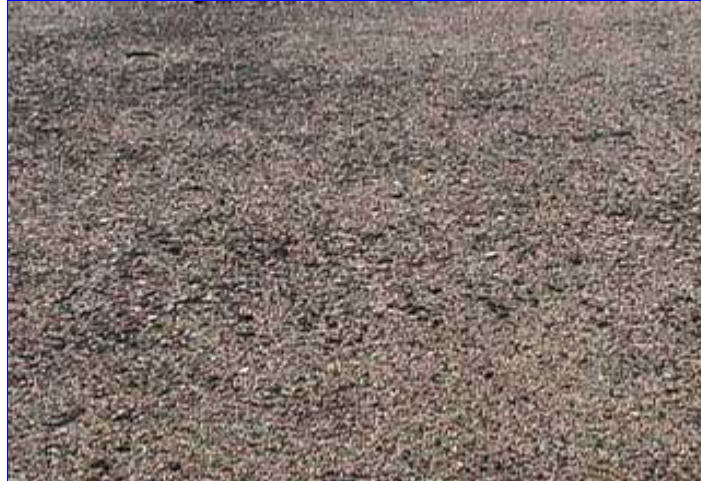
**Built up roof has only minor blistering**

The Board's Report outlines \$112,000.00 is spend on roof repairs starting in 2008. Maybe some minor maintenance on a yearly bases may prove to be a better way to spend the Board's Maintenance money.
