**Grant Alternative School**

**Building Analysis and Review of the Visual (Cost & Picture) Report**

**We Have taken this opportunity to complete our report in reply to the Visual (Cost & Picture) Report completed for Grant Alternative School dated August 16, 2000.**

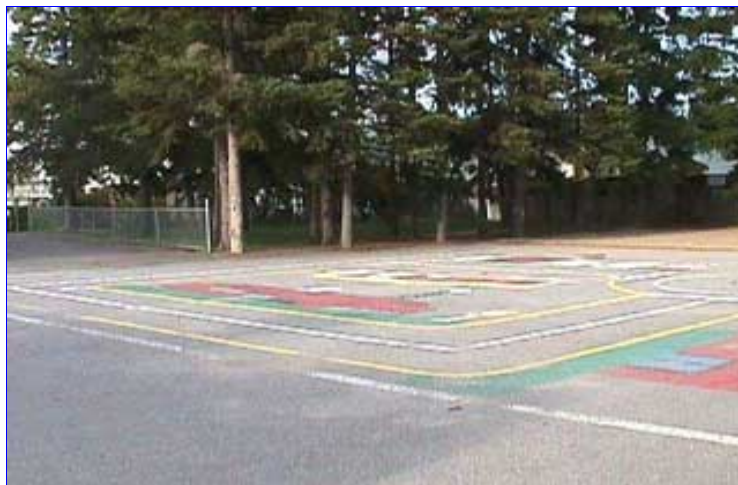
**Even with the pavement painted the kindergarten classes play in the enclosed wooded area behind**

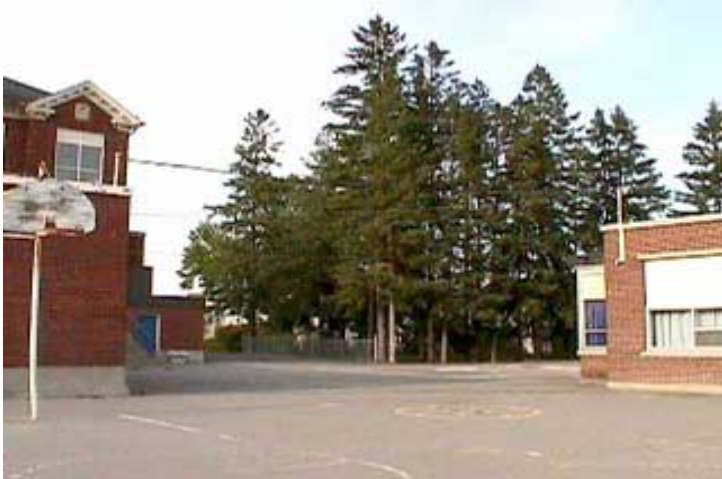
The pavements great but look at trees in the playground

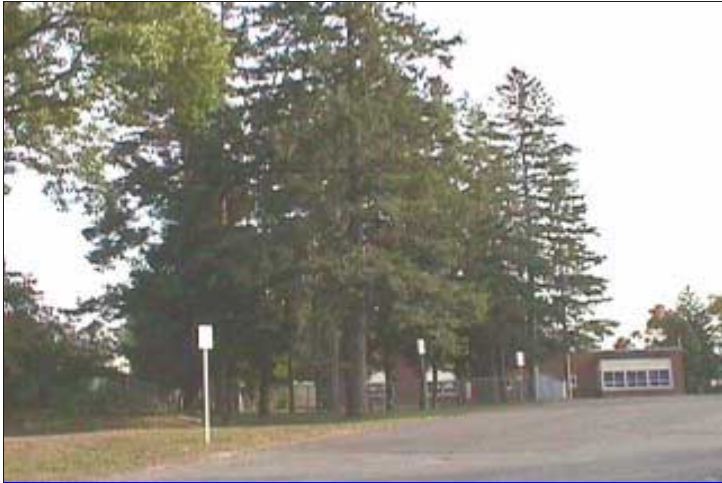
Grant's bus-loading zone is second to none

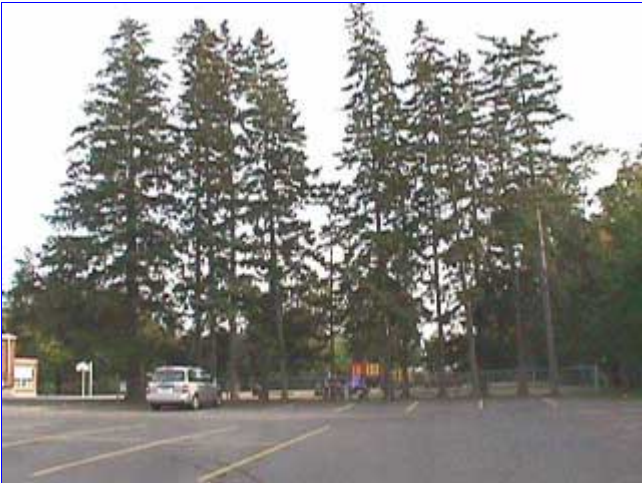
The parking area has a fenced and treed transition zone between the playground and the parking lot

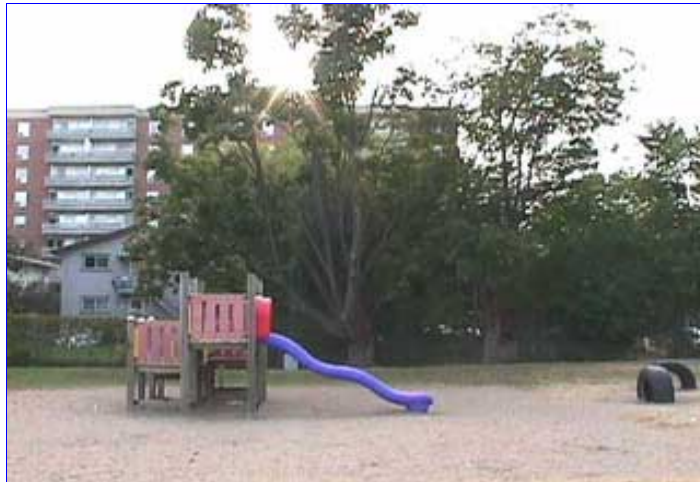
The structures have a large soft sand area are the perimeter

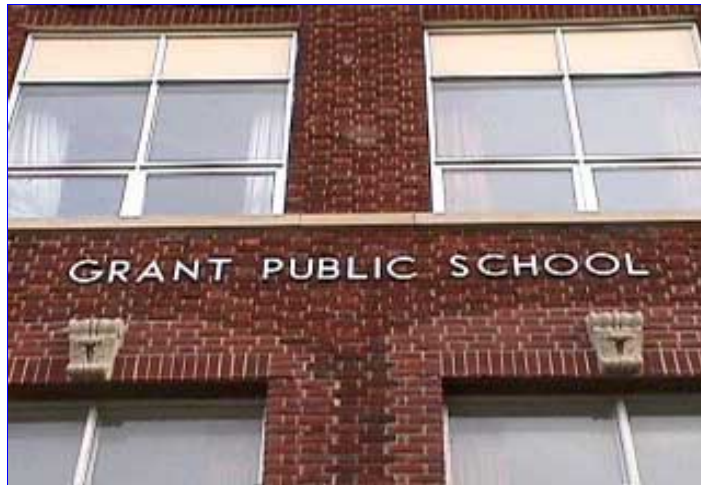
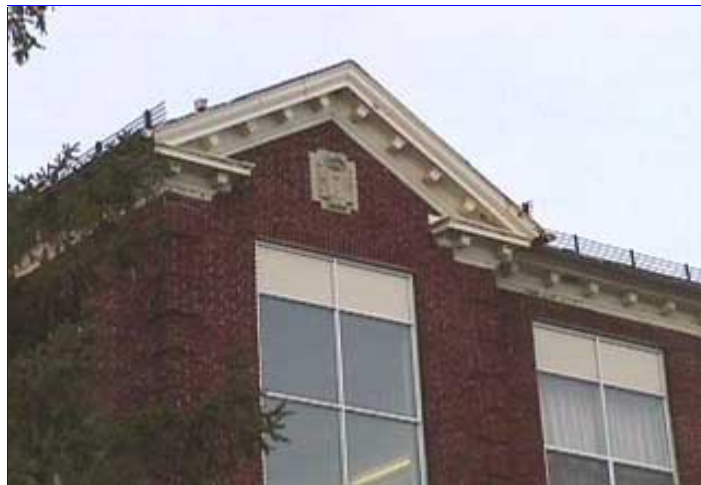
**Detail like this is priceless**

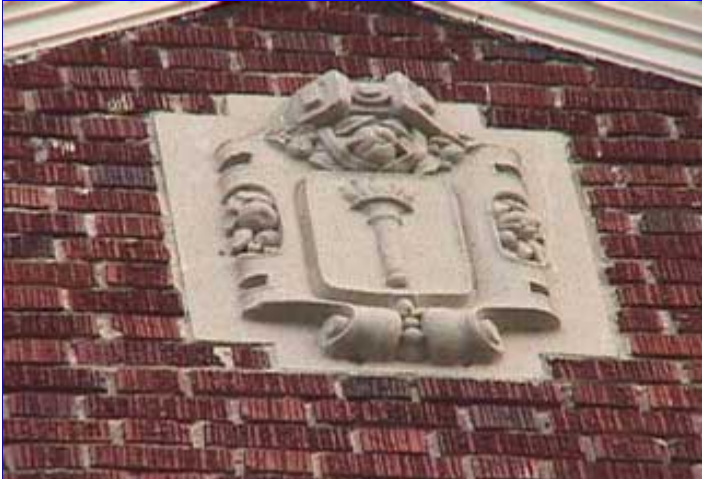
**Outstanding stone work**

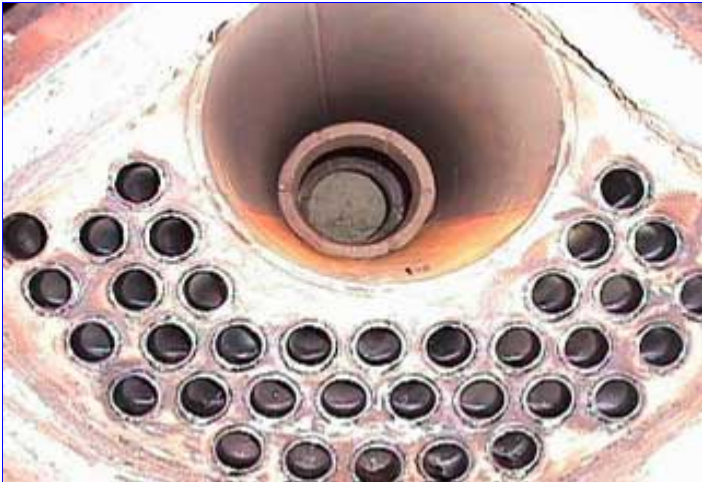
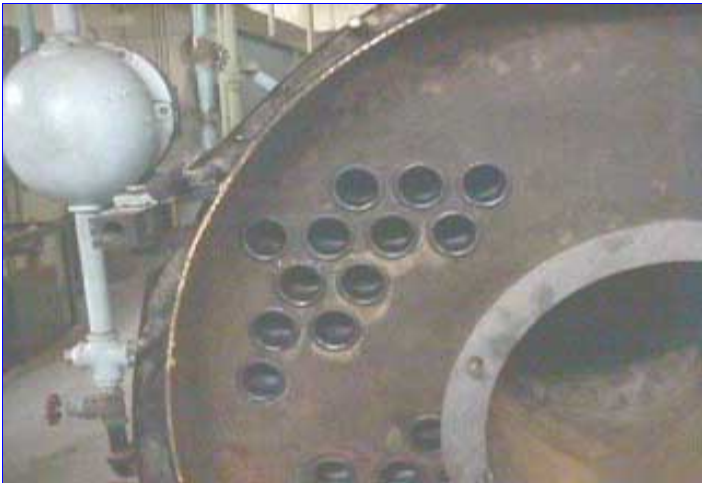
The boilers have been re-cored this summer and appear to be in fine condition. The steam and hot water radiation system should last for many years if the water is conditioned properly. All piping and radiators reviewed appear in good condition.

Photos of the re-corded boilers

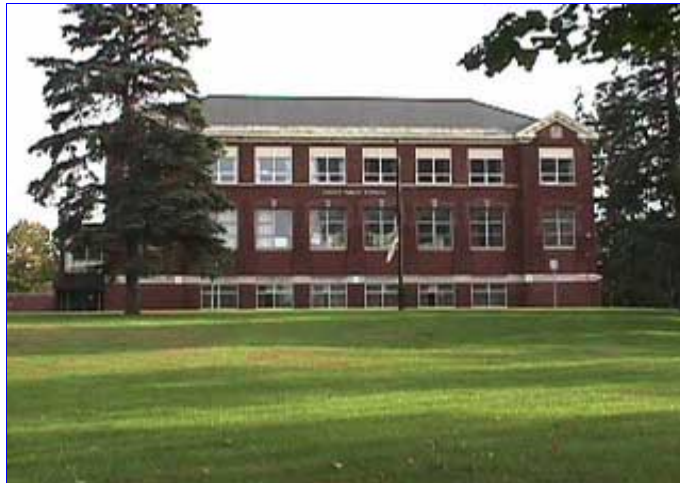
**The painting of the main building soffit and fascia is in poor condition**

The exterior is in need of painting

- No monies outlined for asbestos abatement.
- No note for any exterior painting.
- The rainwater gutters and downspouts require review and repair.
- The rear eastern stair of the main building is badly spalled and poses a safety hazard.
- Some of the face brick on the main building have spalled and should be re-pointed as soon as possible to prevent further damage to the exterior skin.
